*Condenser Tube Examination Using Acoustic Pulse Reflectometry*  
Dr. Noam Amir CTO AcousticEye

## CONDENSER TUBE EXAMINATION USING ACOUSTIC PULSE REFLECTOMETRY

DR. NOAM AMIR ACOUSTICEYE INTERNATIONAL

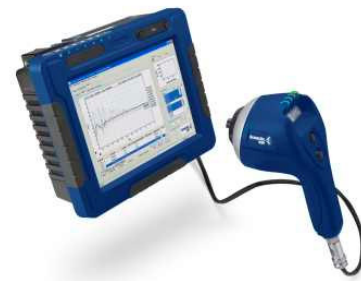
Figure 3: The AcousticEye Dolphin G3™

The first challenge towards creating a mobile APR was to reduce its size. This consisted mainly of reducing the source tubes to 20cm each. Thus the entire assemble of transducer, microphone and source tubes could be fitted into a hand-held probe, as shown in the photograph in Figure 3. All of the electronics related to synthesizing the pulse, amplifying, capturing and analyzing the results, were fitted into a separate unit.

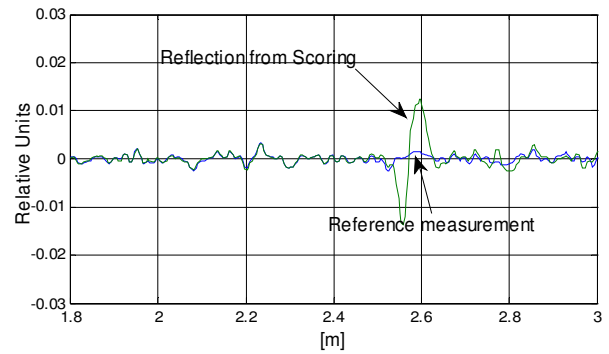
Figure 5: A segment of a measurement showing a reflection from scoring of the tube wall, vs. a reference measurement. Scoring creates a local enlargement of cross section, therefore the reflection is a negative pulse followed by a positive one.

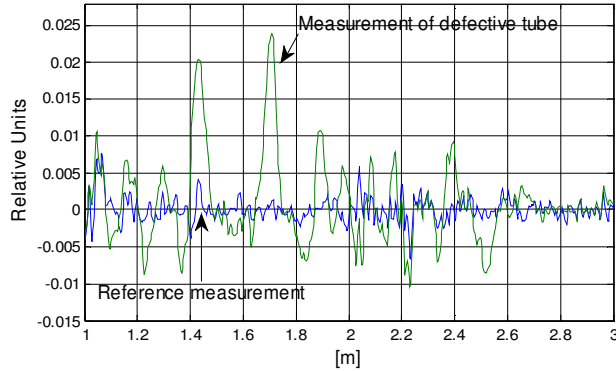
Figure 7: a segment of a measurement taken from the Reading condenser

Due to an extremely tight schedule, measurements were performed and then analyzed on the spot. The tubes were only partially cleaned prior to analysis. 6 tubes out of the 200 that were examined were found to have both large accumulations of deposits and suspected leaks. The measurement from one of these is presented in Figure 7.

These six tubes were plugged. Subsequently, the power plant maintenance team informed us that that the power-plant output increased by 15% the following day.

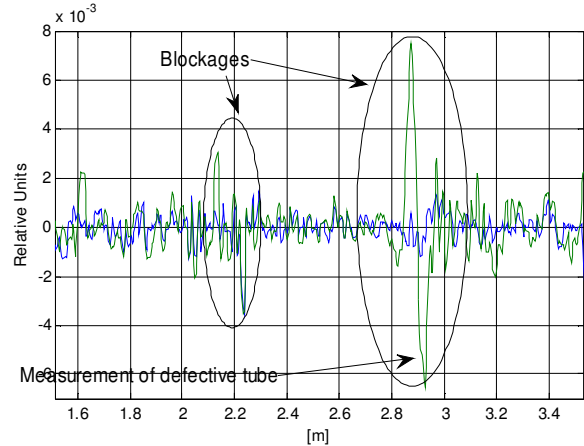
Figure 9: a segment of a measurement showing two local blockages, indicated by a constriction (positive spike) followed by a dilation indicating return to nominal cross section (negative spike).

The Miami condenser, using fresh water in a closed loop as a coolant, exhibited fewer deposits than the Tel-Aviv condenser. The latter uses filtered seawater, which can sometimes cause shellfish to grow in the condensers, blocking some of the tubes. Nevertheless, several full or nearly full blockages were found in the Miami condenser, which could easily have damaged other types of test equipment.

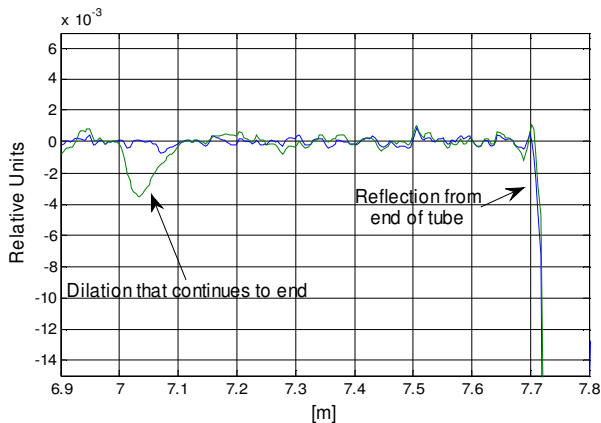
Figure 11: a measurement showing increase in cross section down to the end of the pipe – a dilation not followed by a return to nominal cross section

Finally, an interesting pattern of wall tube degradation appeared in one area of the condenser. A majority of the 80 pipes found in columns 35 to 43 exhibited one of two indications: either a local increase in cross section, indicating pitting, or an increase of cross section throughout approximately the last half meter of the tube, on average. Figures 10 and 11 show one measurement each, typifying the above faults.

The fact that these faults were concentrated in one region of the condenser is probably due to some flow pattern in the condenser. In any case, these tubes were flagged for periodic surveillance or replacement.
